BYERS PIPE

BULLETIN No. 30

An Investigation of Pipe Corrosion

Showing service records of iron, steel
and brass pipe used for hot and cold
water supply lines in 129 Pittsburgh
Apartment Buildings

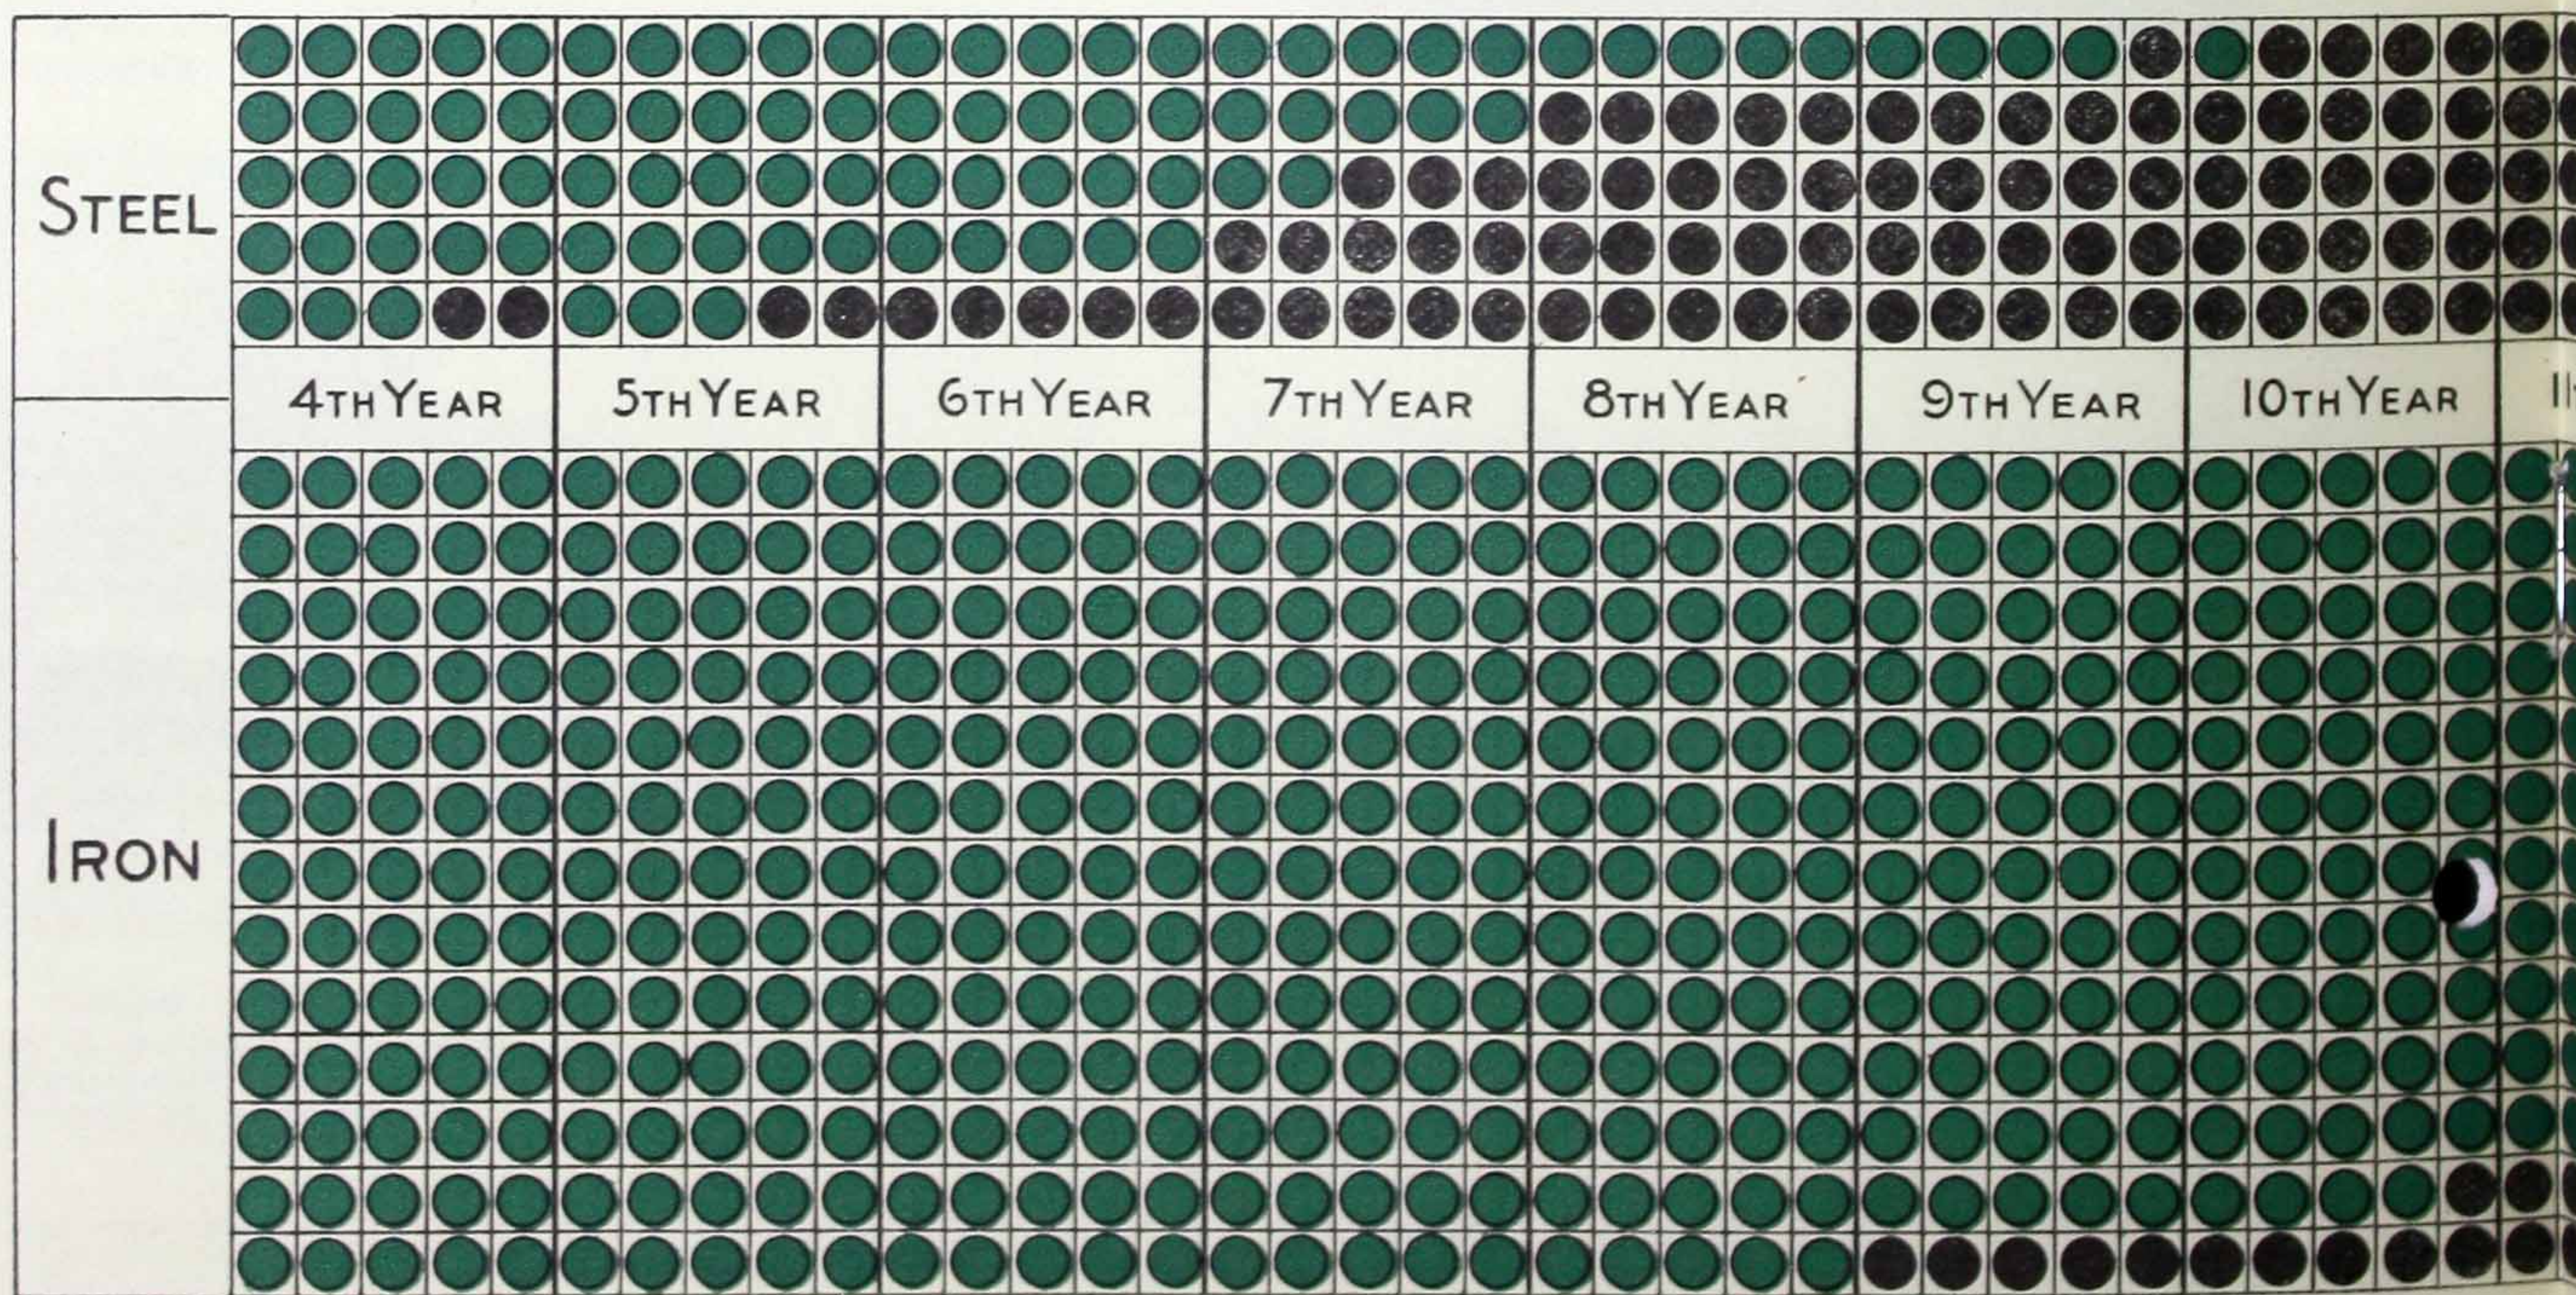
to much less corrosion, lasting so long that no definite idea can, for some years yet, be formed as to their average life. The significance of the data lies in the *ratio of life* established between iron and steel pipe,—namely, 2 to 1 in favor of *genuine wrought iron*.

Using a similar line of reasoning, we might point to the fact that certain steel installations lasted only 4 years and certain iron installations from 16 to 18 years, outlasting steel from 4 to 5 times. Likewise we might even undertake to claim—and with considerable good evidence to back this claim—that **extra heavy iron pipe lasts longer than brass pipe.**
